# The UK's Evolving Physical Landscape: Christchurch Bay

## Where is Christchurch Bay?

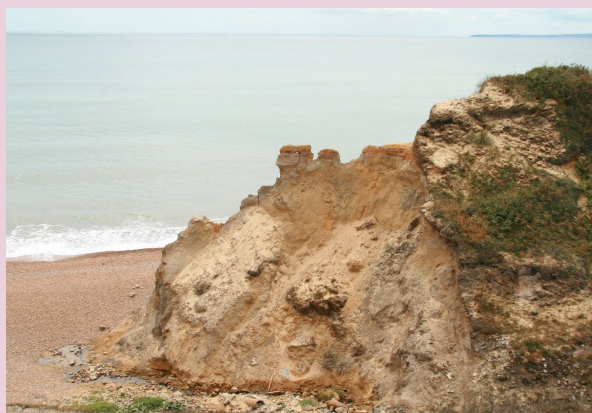
The cliffs on the coastline surrounding Christchurch Bay are made of **sandstones and clays**. These rock types are easily eroded by the sea and through weathering as they are very soft.

The image below was taken in July 2020, since then the photographer wrote that this landform has already been eroded away.

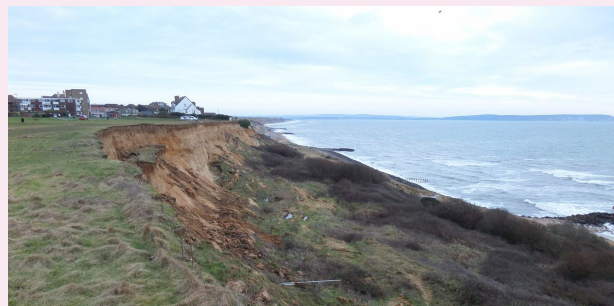
(Source: [wessexcoastgeology.soton.ac.uk/barteros.htm](http://wessexcoastgeology.soton.ac.uk/barteros.htm))

Decades of erosion has caused the cliff edge to retreat by **tens of metres**, and now many **buildings are very close to the cliffs**. In some cases, residential areas may only be several metres away from the cliff edge.

**Extra weight on the cliff tops from buildings** combined with existing instability at the **cliff bases** (caused by erosion) can create issues. The cliffs become too unstable and **collapse under their own weight**. Several houses and a cafe have already been lost to cliff collapses.

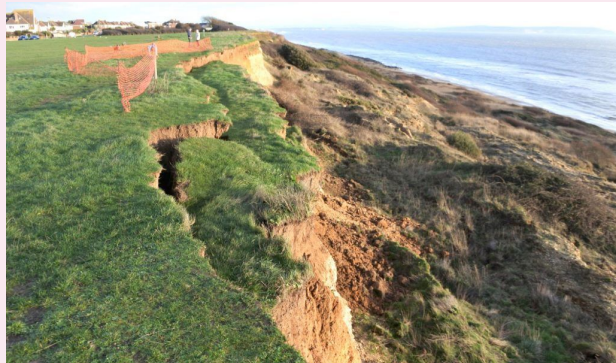
As well as being vulnerable to erosion, this rock type is also very **permeable**. **Water infiltrates easily and saturates the cliffs** during wet periods, which adds weight, increases instability and encourages **mass movement** and **collapse**.

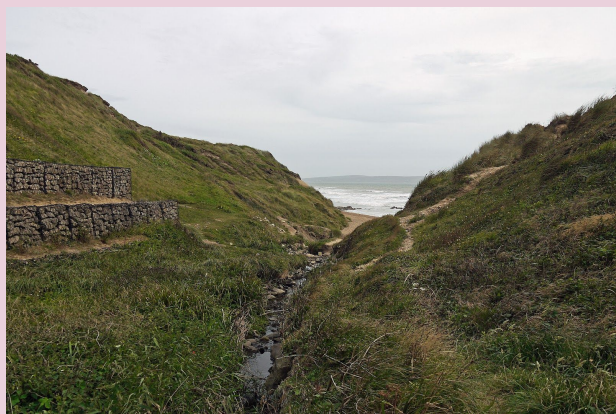
Several rivers in the area flow to the coast through steep sided coastal gorges known as **chines**.

The rivers usually infiltrate and flow through the **permeable rock** by the time they reach the coast, which adds a lot of water to the cliffs and can cause instability, as well as erosion.

*Becton Bunny, a famous chine in the area.*  
 (Source: <http://walkinginthecountry.blogspot.com>)

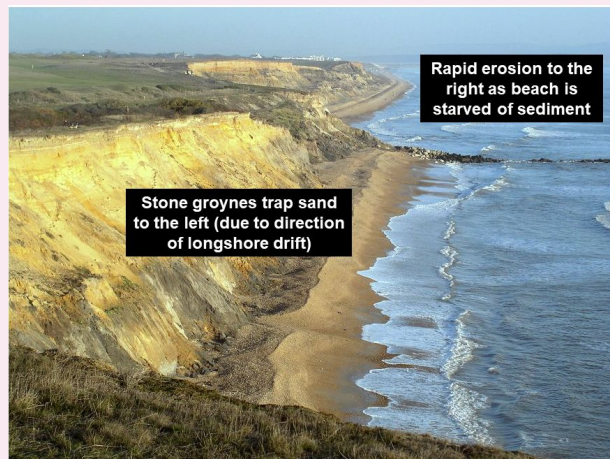
For example, **cliff erosion** at Naish Holiday Park in Barton-on-Sea has increased rapidly as a result of the groyne located further west, seen in the image below.

**Groynes** have been built on the coastline of Christchurch Bay to protect cliffs to the west, but this has **starved the beach of sediment further east** and caused very rapid erosion.

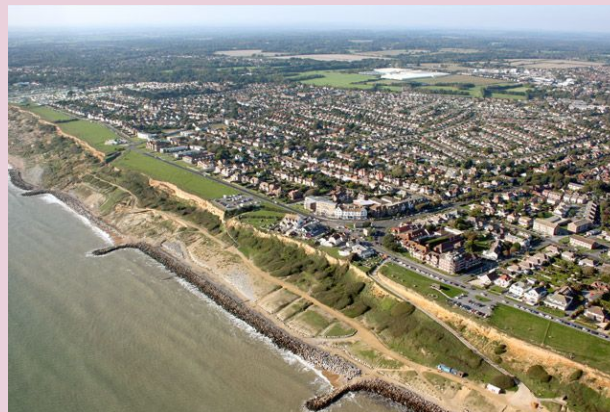
*Barton-on-Sea (Groyne visible on coast).*  
 (Source: [www.mitchells.uk.com/about-us](http://www.mitchells.uk.com/about-us))

Poor planning around Barton-on-Sea has created an issue referred to as "**terminal groyne syndrome**".

Terminal groyne syndrome is a coastal process where groyne (structures that trap sediment from longshore drift) cause **sediment buildup** on one side of the groyne (in the direction of longshore drift), but **starve an area of sediment** on the other side.
