The UK's Evolving Physical Landscape: Sheffield Floods

The Sheffield Floods of 2007

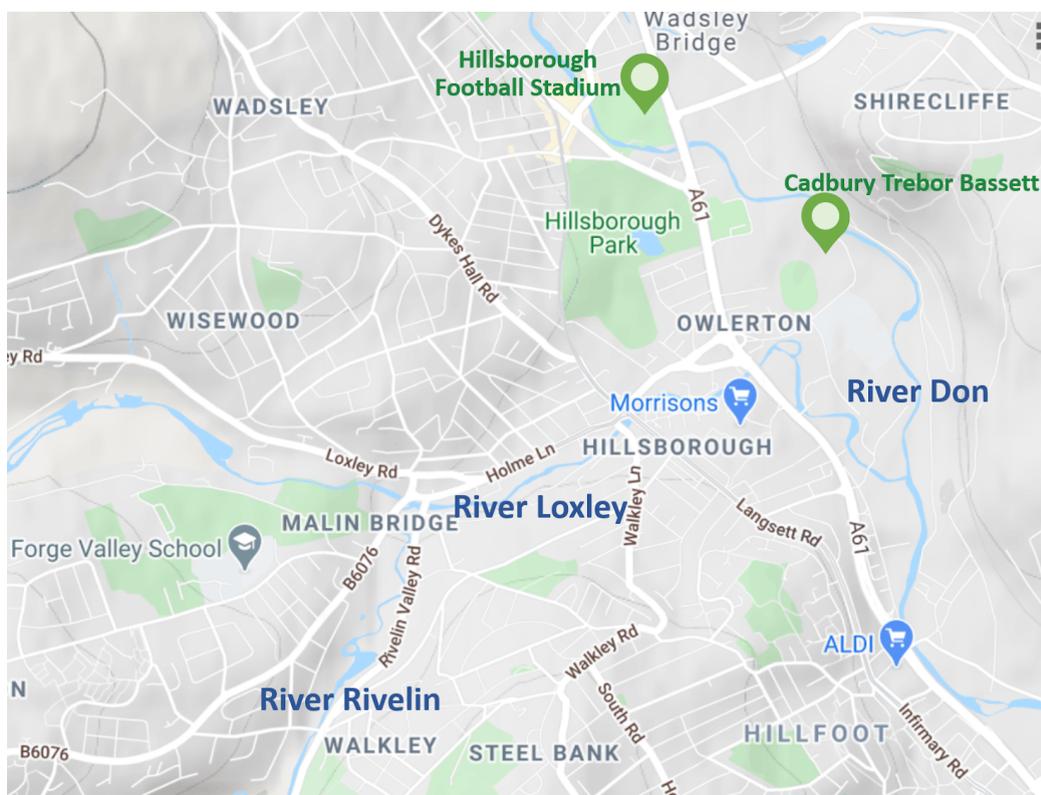
Hillsborough, Sheffield. (Source: adapted from Google Maps)
This work by [PMT Education](https://www.pmt.education) is licensed under [CC BY-NC-ND 4.0](https://creativecommons.org/licenses/by-nc-nd/4.0/)

Several areas of Sheffield were severely affected, including **Lower Don Valley, Brightside and Hillsborough**. Hillsborough is shown in the map below, located at the **confluence of the rivers Don, Loxley and Rivelin**. This area was hit hard by the River Don overflowing, and areas such as the **Hillsborough Football Stadium** and the **Cadbury Trebor Bassett Headquarters** were in floodwaters up to **6 feet high**.

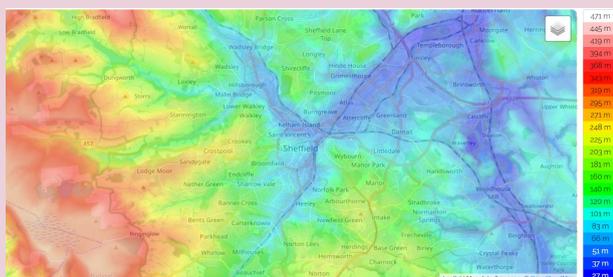
Elevation of Sheffield. Red = high. Blue = low. (Source: www.topographic-map.com/maps/7yb5/Sheffield/)

Several hills surround Sheffield, in fact it is known as the "city of seven hills" due to its **topography**. It also sits at the foot of the **Pennines**. Rainfall flows rapidly down the surrounding hills as **runoff** and drains into Sheffield's river systems, filling them quickly.

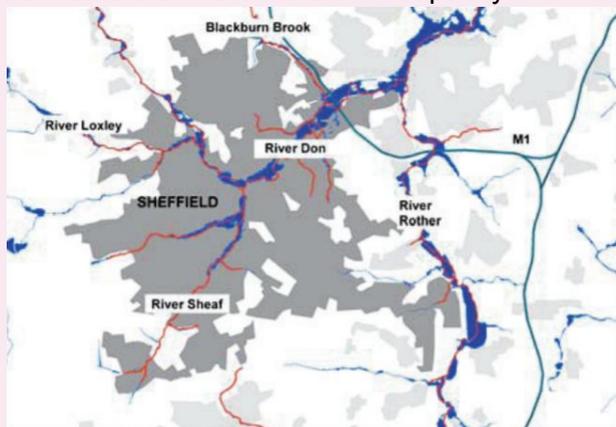
Areas of Sheffield that Flooded in June 2007 (flood area in blue). (Source: [Environment Agency](#))

Several rivers flow directly into the **River Don** (seen in the image below). These rivers continued to contribute to the Don's discharge as heavy rainfall continued, and eventually the channel became overwhelmed with water and **burst its banks**.

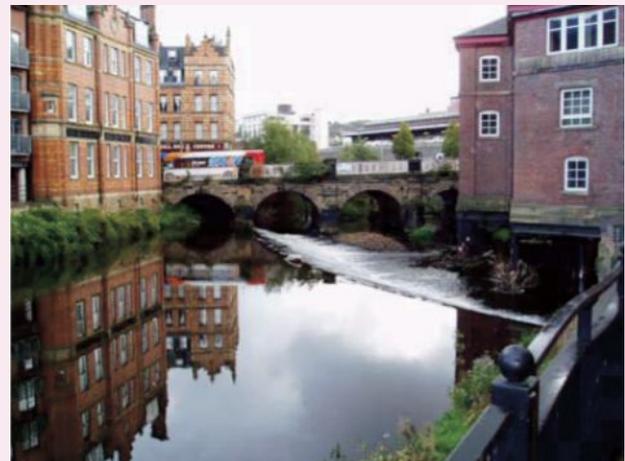
Buildings directly next to the River Don. (Source: [Environment Agency](#))

Urbanisation in Sheffield has left the River Don and its tributaries with **no space to naturally expand and flood**, which is important for flood risk reduction.

These rivers are squeezed into **man-made channels (called culverts)** which **direct and manage water**. This means when the rivers do swell, they have no space to flow onto floodplains, and instead **flood homes and businesses**.
