The 1994 Northridge earthquake occurred on January 17, at 4:30:55 a.m. PST and was centered in Reseda, a neighbourhood in the north-central San Fernando Valley region of Los Angeles, California. It had a duration of approximately 10–20 seconds and had a magnitude of 6.7. Strong ground motion was felt as far away as Las Vegas about 220 miles from the epicentre. The death toll was 57, with more than 5,000 injured. In addition, earthquake-caused property damage was estimated to be more than \$20 billion, making it one of the costliest natural disasters in U.S. history.

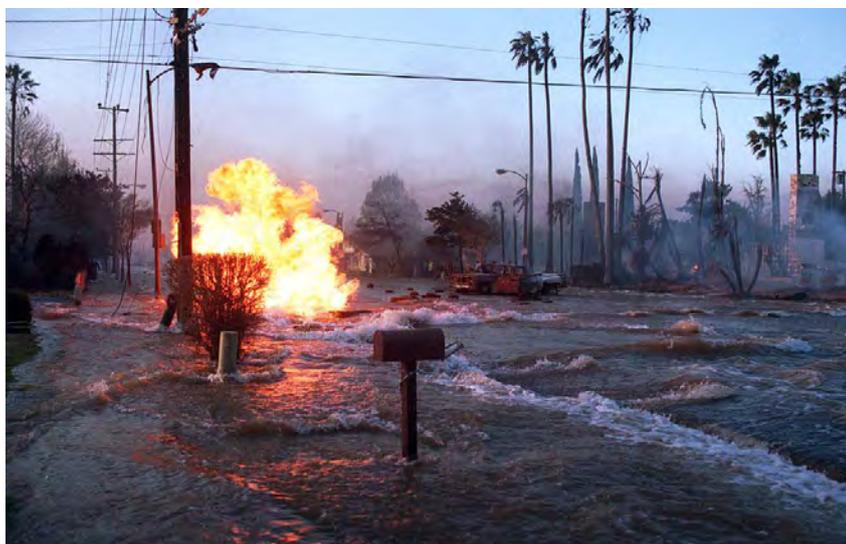
Gas from a ruptured supply line burns as water from broken water main floods Balboa Boulevard in the Granada Hills area of Los Angeles, on January 17, 1994. The fire from the gas main destroyed two homes.

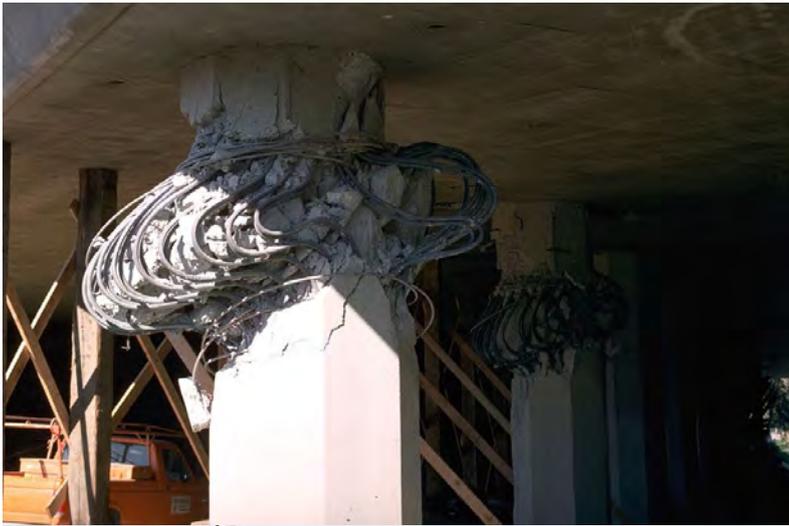
Steel-reinforced concrete support beams damaged by the 1994 earthquake

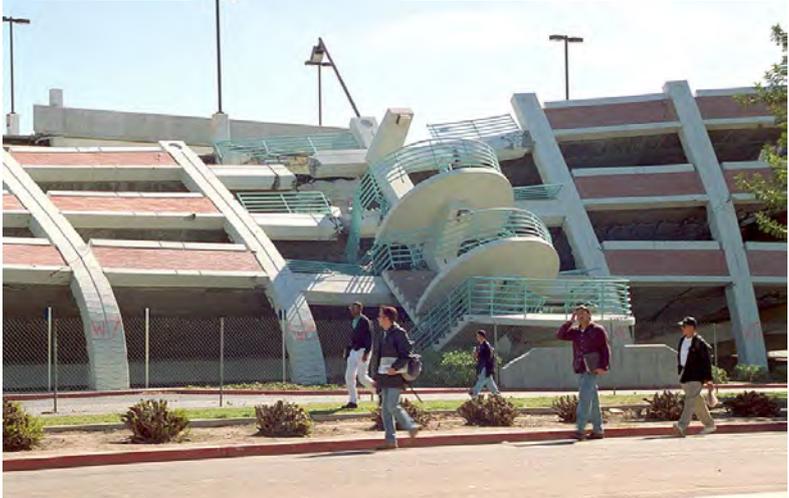
University of California, Northridge, students walk by a parking structure that was heavily damaged on the CSUN campus in the January 17 earthquake.

The Northridge Meadows apartment complex was one of the well-known affected areas in which sixteen people were killed as a result of the building's collapse. The Northridge Fashion Center and California State University, Northridge also sustained very heavy damage—most notably, the collapse of parking structures. The earthquake also gained worldwide attention because of damage to the vast freeway network, which serves millions of commuters every day. The most notable of this damage was to the Santa Monica Freeway, Interstate 10, known as the busiest freeway in the United States, congesting nearby surface roads for three months while the freeway was repaired.
